Fourth Quarterly Report

**United States Environmental Protection Agency
Administrative Order No. CWA-04-2010-4772**

**Period
July 1, 2011 –
September, 2011**

October 2011

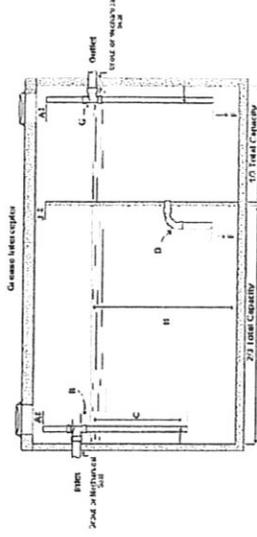
- A.) Minimum 6", but not less than pipe diameter.
- B.) Inlet pipe invert to be 2 1/2" above liquid surface.
- C.) Inlet pipe to terminate 2/3 depth of water level.
- D.) 90 degree Sweep, minimum size- 6"
- E.) 12" from floor to end of sweep.
- F.) 12" from floor to end of outlet pipe
- G.) Outlet pipe no smaller than inlet pipe, minimum- 4"
- H.) Minimum depth of liquid capacity- 42"
- I.) Maximum distance from ceiling- 6"

Is an underground tank with usual capacities ranging from 1,000 gallons to 3,000 gallons. Interceptors need to be cleaned (pumped out) of complete contents at a recommended minimum frequency of every 90 days. Some facilities will need to pump interceptors more frequently (i.e. monthly). Class 2 through Class 5 food service establishments need to have grease interceptors installed.

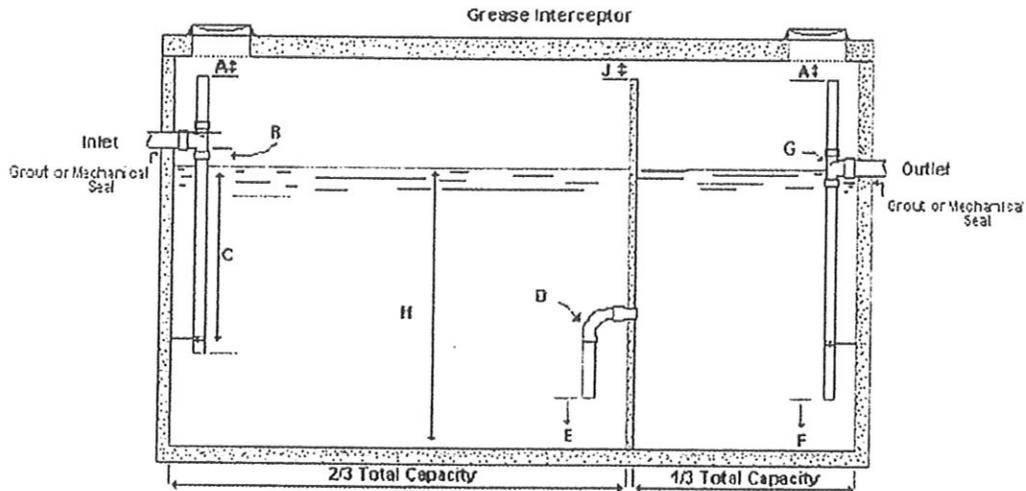
Illustration

- A.) Minimum 6", but not less than pipe diameter.
- B.) Inlet pipe invert to be 2 1/2" above liquid surface.
- C.) Inlet pipe to terminate 2/3 depth of water level.
- D.) 90 degree Sweep, minimum size - 6".
- E.) 12" from floor to end of sweep.
- F.) 12" from floor to end of outlet pipe.
- G.) Outlet pipe no smaller than inlet pipe, minimum - 4".
- H.) Minimum depth of liquid capacity - 42".
- J.) Maximum distance from ceiling - 6".

6. Note: Concrete materials and other grease interceptor materials shall meet the American National Standards Institute, Inc. (ANSI) and International Association of Plumbing and Mechanical Officials (IAPMO) standards.
7. Marking and Identification – Prefabricated gravity grease interceptors shall be permanently and legibly marked with the following:
 - a. Manufacturer's name or trademark, or both
 - b. Model number
 - c. Capacity
 - d. Month and year of manufacture
 - e. Load limits and maximum recommended depth of earth cover in feet; and
 - f. Inlet and outlet

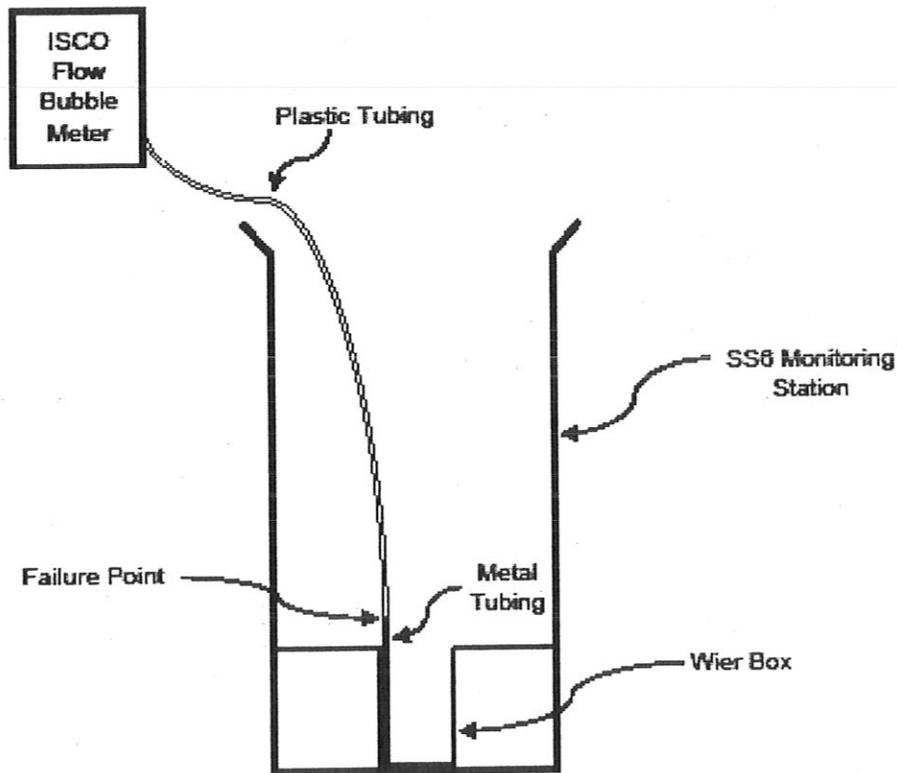
Figure 1

Schematic of SS6 Monitoring Station

- Wednesday, September 7, 09:00: Repairs are complete and the bubble meter is providing correct readings as verified by subsequent checks throughout the day.

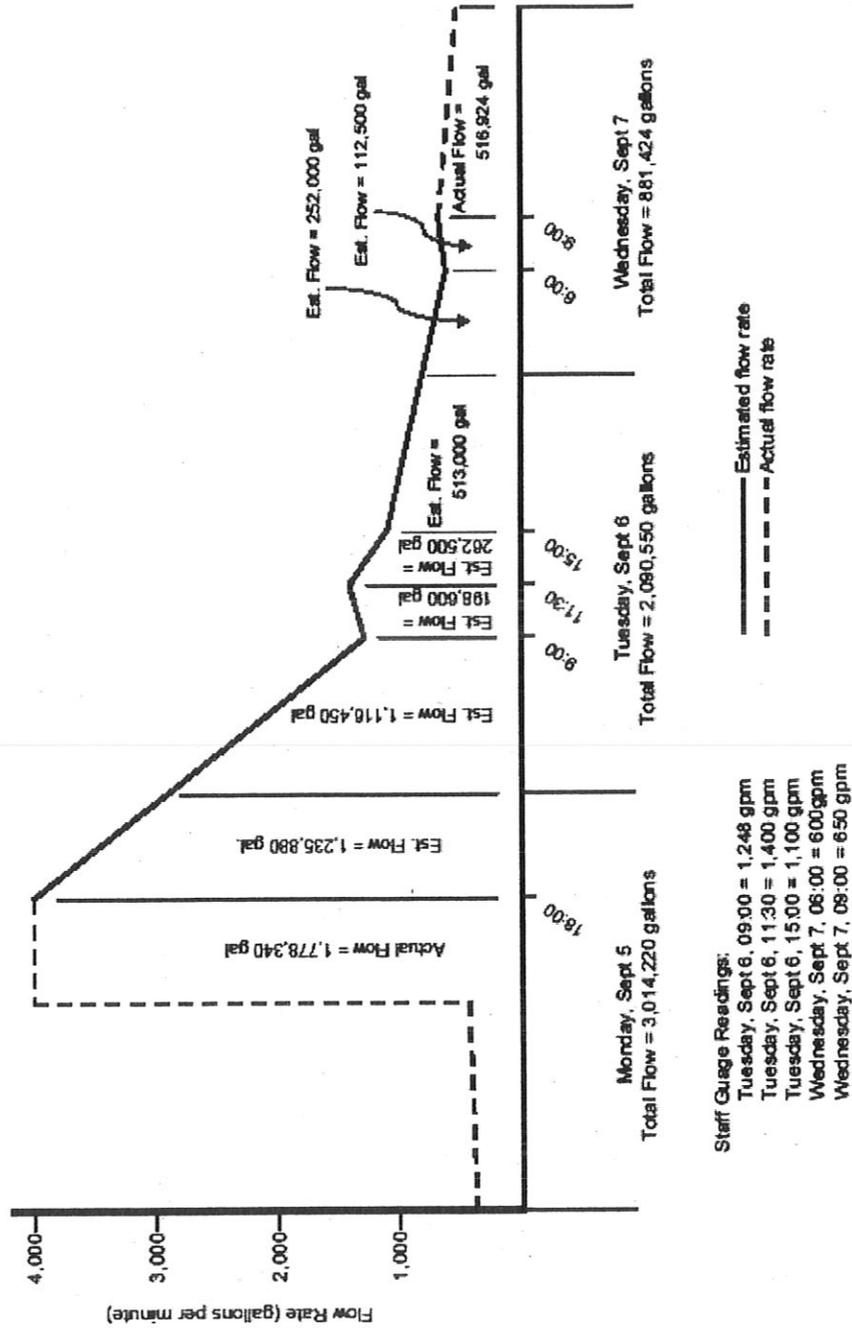
**Y-12 National Security Complex
September 5-7, 2011
Estimated Sanitary Sewer Hydrograph**

Due to the lack of confidence in the data gathered by the bubble meters, it is necessary to estimate the flow in the sewer system from 18:00, September 5, through 09:00, September 7, a period of 39 hours. This estimate was accomplished by taking the flow rates as measured by the staff gauge throughout this period and using a linear assumption between each data point. Table 1 indicates the flow rates corresponding to the depth on the staff gauge.

Figure 2 contains a hydrograph of the actual and estimated periodic and total daily flows for these three days. Figure 3 is a graphical depiction of the rainfall received during this same 3-day period.

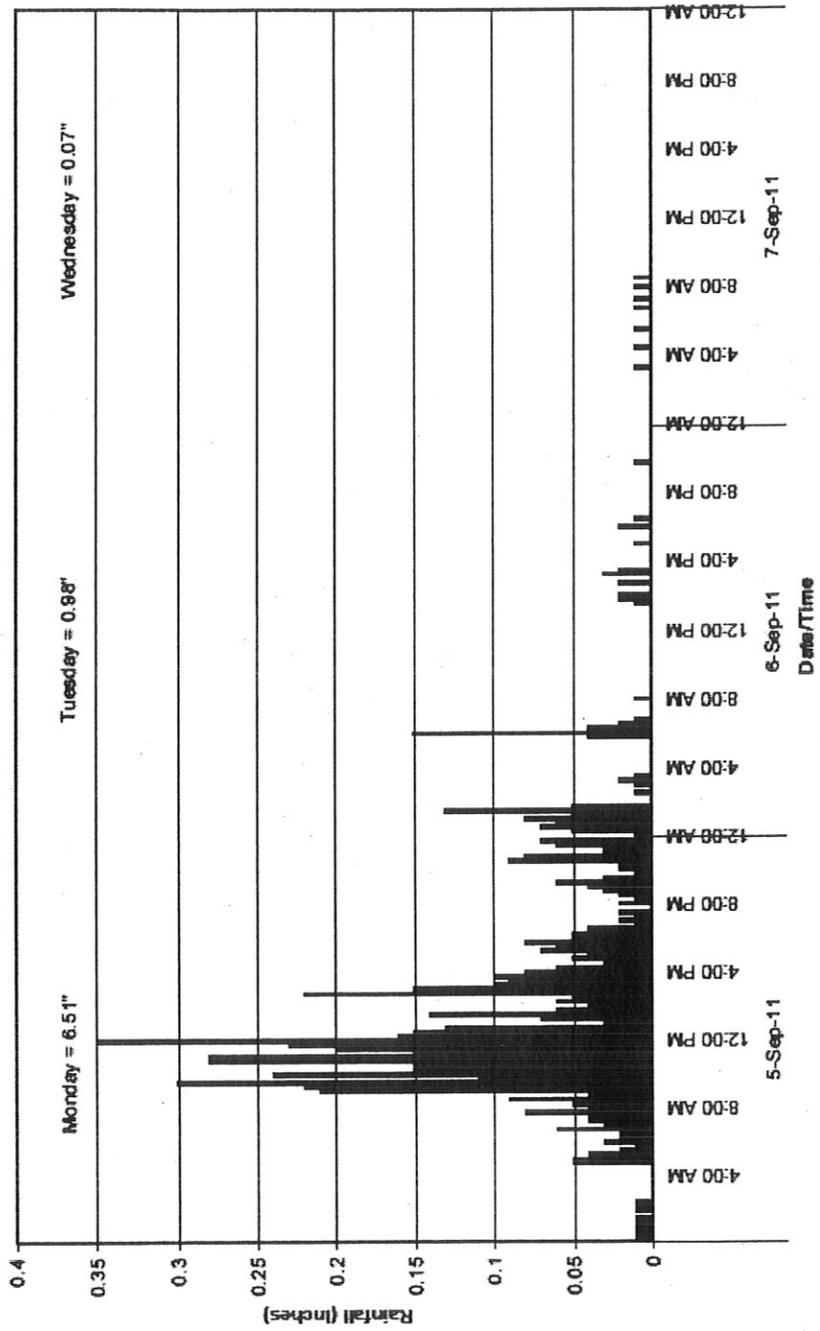
Y-12 Rainfall, September 5-7, 2011
Total = 7.56 inches
Tropical Storm "Lee"

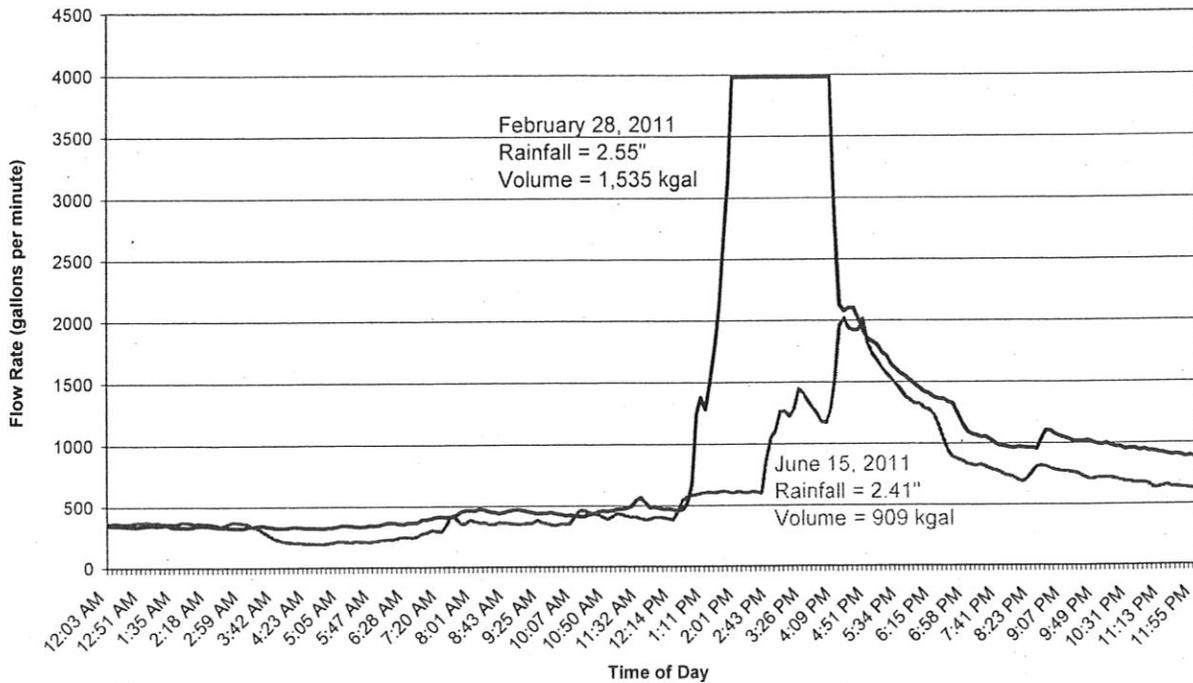
Figure 1
Y-12 Sanitary Sewer Flow Rates
February 28, 2011 vs. June 15, 2011

While it is impossible to determine the exact effect of any one repair, it is possible to compare the total sewer flow during two similar rain events. Figure 1 shows the hydrograph of the sanitary sewer during a February 28, 2011, rain event which occurred prior to the majority of repairs (blue line, 2.55 inches of rain). It also shows the hydrograph during a June 15 rain event (red line, 2.41 inches of rain). Each rain event was approximately 3 hours in duration and of similar intensity. The February 28 rain event resulted in a surcharge of the monitoring location for approximately 2 hours. The June 15 rain event did result in increased flow, however, the effect was not nearly as severe.

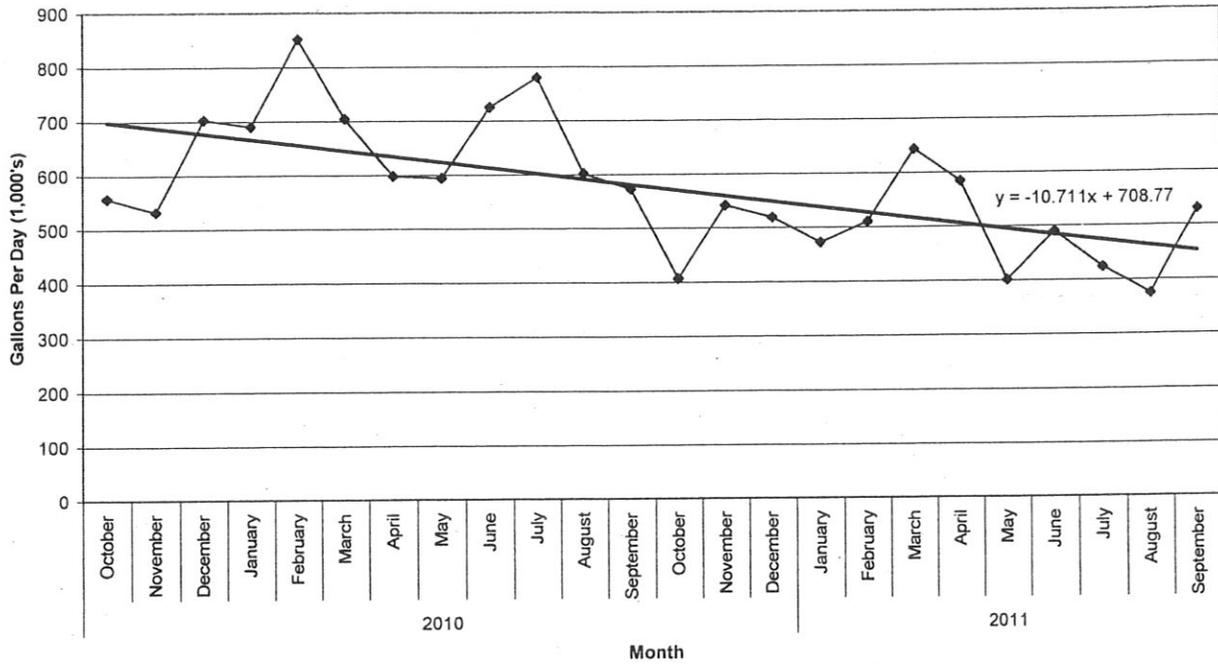
Figure 2
Y-12 Sanitary Sewer System
Average Daily Flow (1,000 gallons)

As discussed in the previous section, actions have been taken to reduce the base flow in the Y-12 Complex sanitary sewer system. These have had a positive impact on total flow, both during rain events and dry weather. Over the previous 18 months, the typical base flow in the Y-12 Complex sanitary sewer system has been reduced from in excess of 700,000 gallons per day to less than 500,000 gallons per day (as shown by the regression line on Figure 2). This is the combined result of the actions taken to date to reduce both I&I and base flow.
