Twelfth Quarterly Report

United States Environmental Protection Agency
Administrative Order No. CWA-04-2010-4772

Period
July 1, 2013 –
September 30, 2013

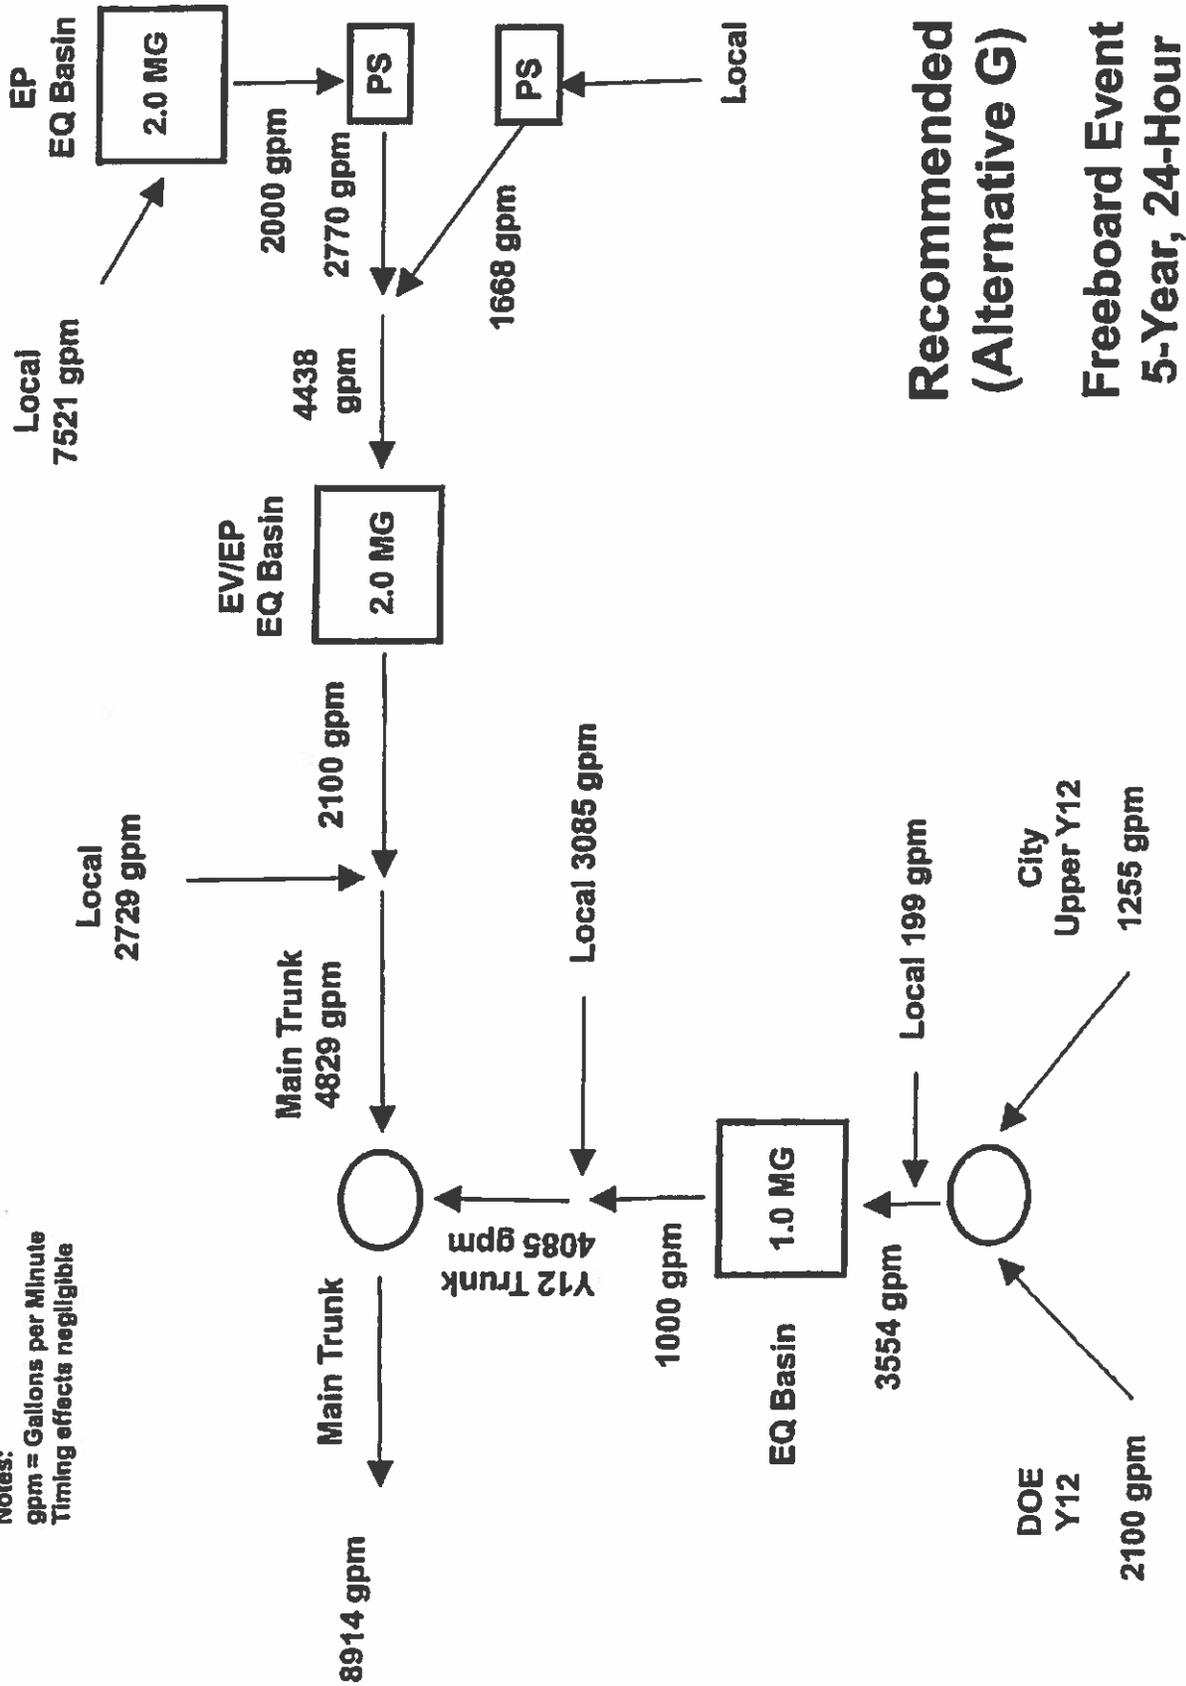
Figure 1 is a diagram of alternative G recommended in the rehabilitation plan.

**Recommended
 (Alternative G)**
**Freeboard Event
 5-Year, 24-Hour**

The Rehabilitation Plan proposed three equalization (EQ) basins to be constructed to shave peak instantaneous flows which were predicted to cause SSO's. These predicted flows were after the rehabilitation of sewers was complete. The freeboard design storm used was a 24-hour event with a 5-year recurrence interval. It was determined that the EQ basins were the most cost-effective option for controlling SSO's.

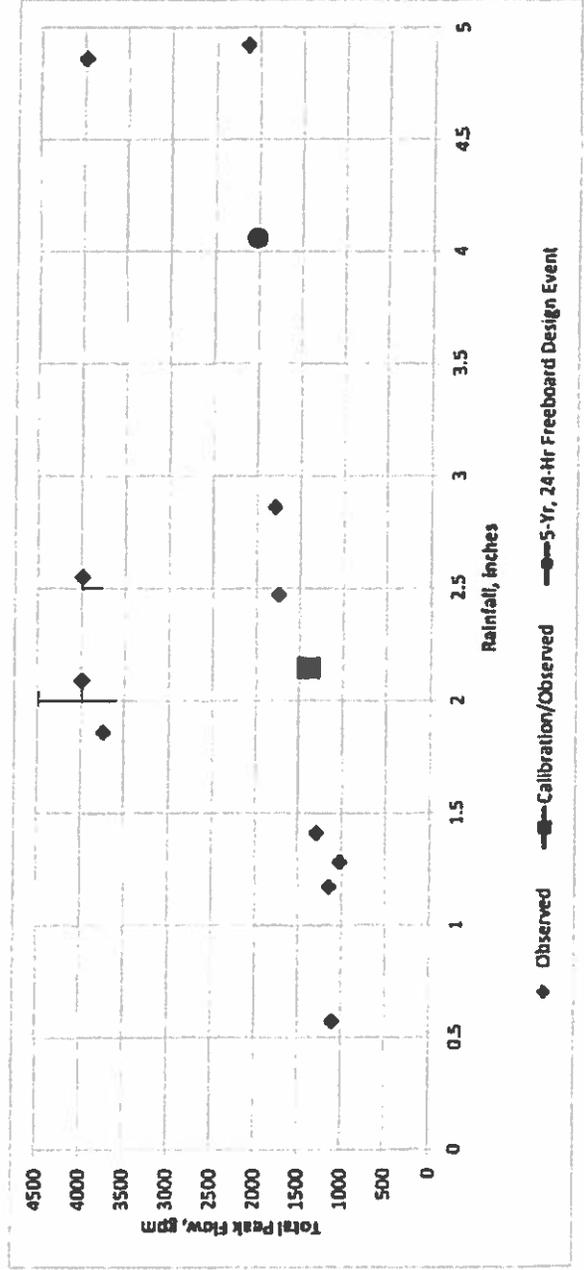
To size the EQ basins, it was imperative to have a model which predicted flows from various sections of the City. Figure 2 shows observed flows from the Y-12 Complex and the resultant predicted flows from various rainfall events. As can be seen in Figure 2, the predicted peak instantaneous flow rate from Y-12 is 2,030 gpm. Generally, the Y-

10.19.11 1400 300 1100 12 2.15 < annual event; used for model calibration
 5-yr, 24-hr 2030 400 1630 24 4.06 5-yr, 24-hr freeboard design event model result

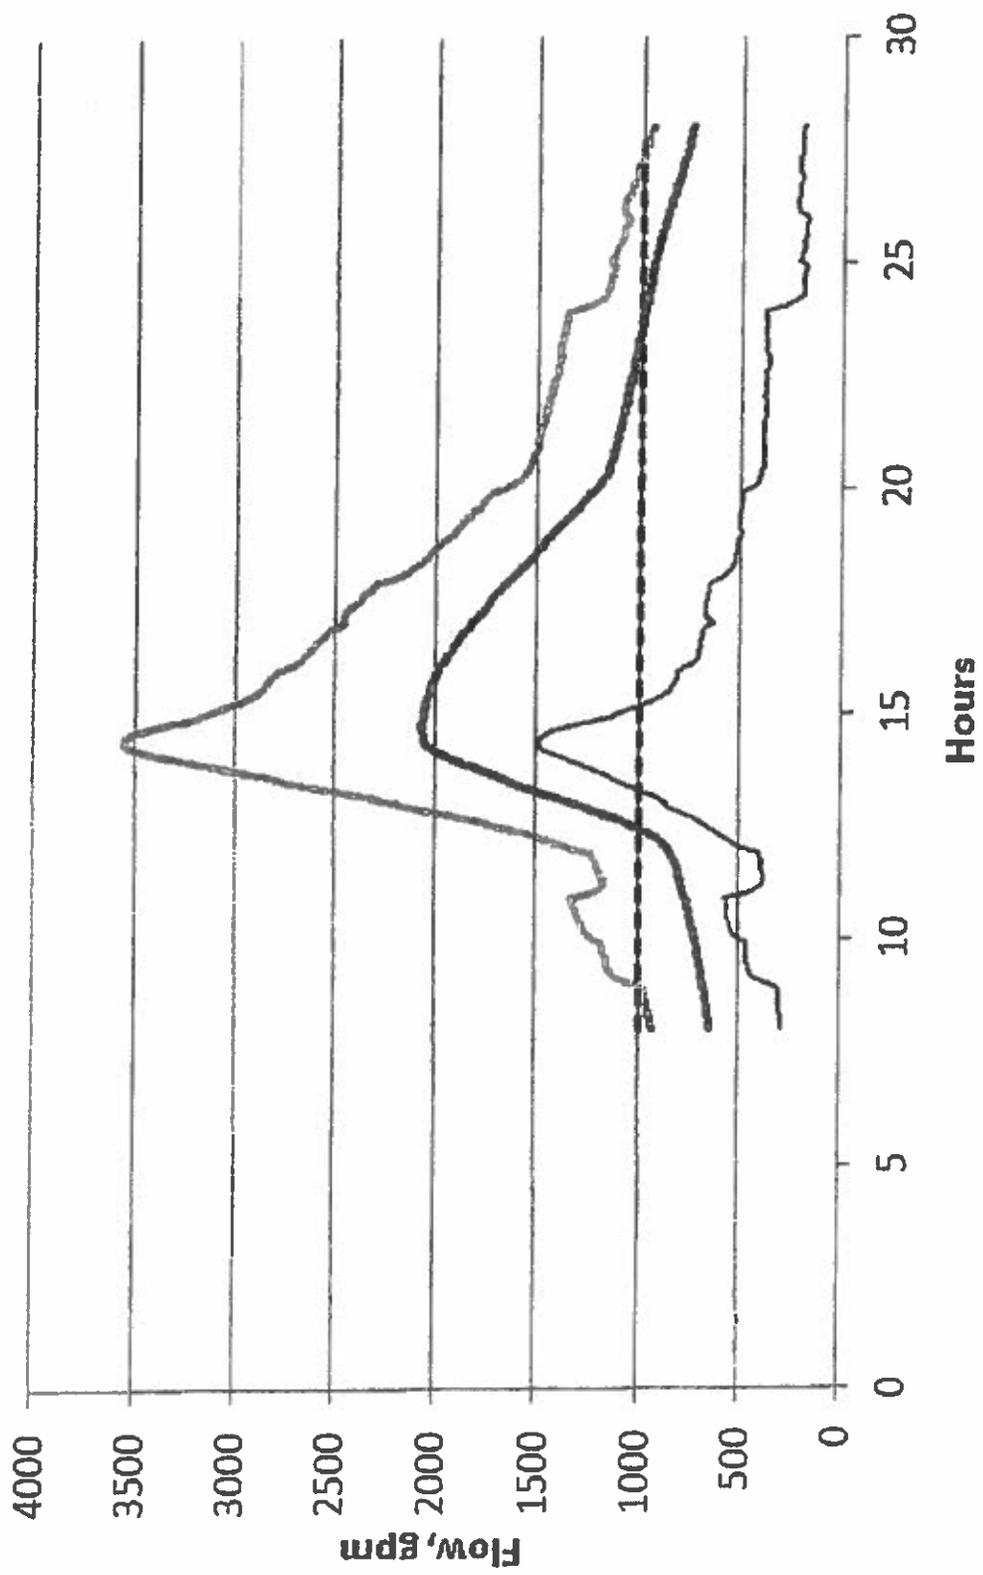
Figure 4

— COR
— DOE
— COR+DOE
- - - Limit

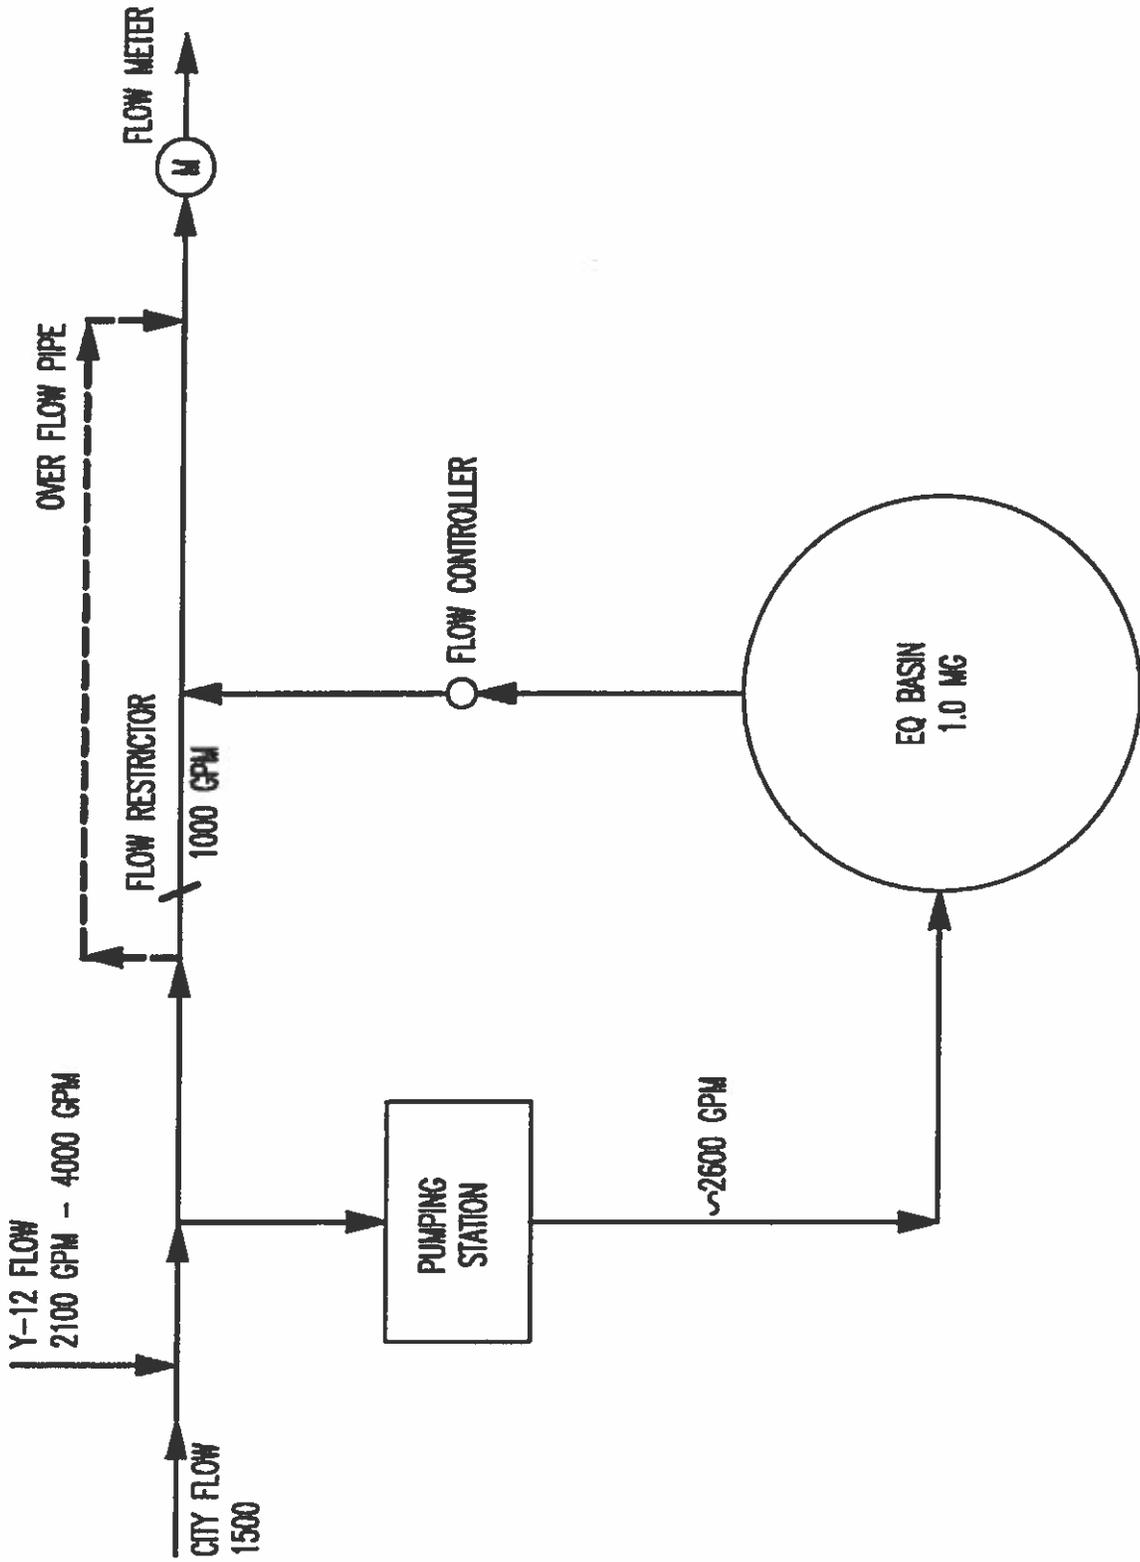
Figure 5 shows the schematic of how to effectively control the flow rate in the sewer to less than 1,000 gpm. A flow restrictor would be constructed in the sewer which would only allow 1,000 gpm to pass. This restrictor would cause a water level rise in the sewer. An overflow pipe would be installed to divert the excess flow into a pumping station which would transfer the extra flow to the EQ basin. When the flow rate diminishes in the sewer, stored water would be released at a controlled rate. Another by-pass arrangement would be available to handle flows with a storm greater than a 5-year event.
