Eighteenth Quarterly Report

**United States Environmental Protection Agency
Administrative Order No. CWA-04-2010-4772**

**Period
January 1, 2015 –
March 31, 2015**

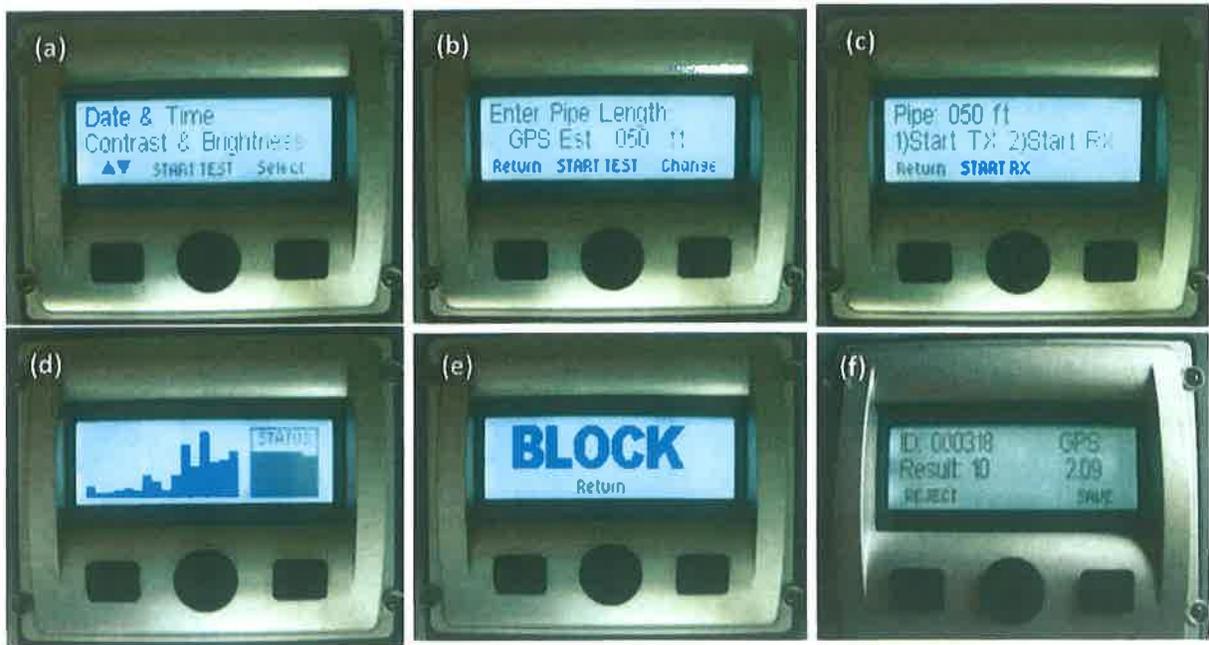
Figure 9 Menu Sequence for RX acoustic measurement operation. (a) Main Menu; (b) Pipe Length Menu; (c) Start Test Instruction Menu; (d) RX Real Time Display; (e) Pipe Segment Assessment; (f) Pipe Segment Evaluation.

The device relies on the fact that air flowing through the free space in a pipe acts very similarly to water. It consists of an acoustic transmitter (TX) and receiver (RX). The TX introduces a known sound into the pipe typically through a manhole. The RX listens at an adjacent manhole. Using a sophisticated algorithm to measure the sound energy it hears, the RX is able to make a blockage assessment that is immediately displayed to the user and also provides the ability to transfer that data to a computer file that can be further manipulated and analyzed by the SL-RAT user.

The TX sits on top of an open manhole and the RX sits on top of an open adjacent manhole. It uses the sound waves instead of sight to determine if a sewer line is open, partially or completely blocked. The TX emits a repeating series of tones similar to a musical scale to the RX which rates the sewer line segment on a scale of 1–10 with one of five possibilities (see appendix for more information):
